**AIR FORCE FLIGHT  
EVALUATION (SYSTEMS)  
OF THE  
A-10A PROTOTYPE AIRCRAFT**

**TECHNICAL REPORT No. 73-3**

**MARCH 1973**

**AIR FORCE FLIGHT TEST CENTER  
EDWARDS AIR FORCE BASE, CALIFORNIA  
AIR FORCE SYSTEMS COMMAND  
UNITED STATES AIR FORCE**

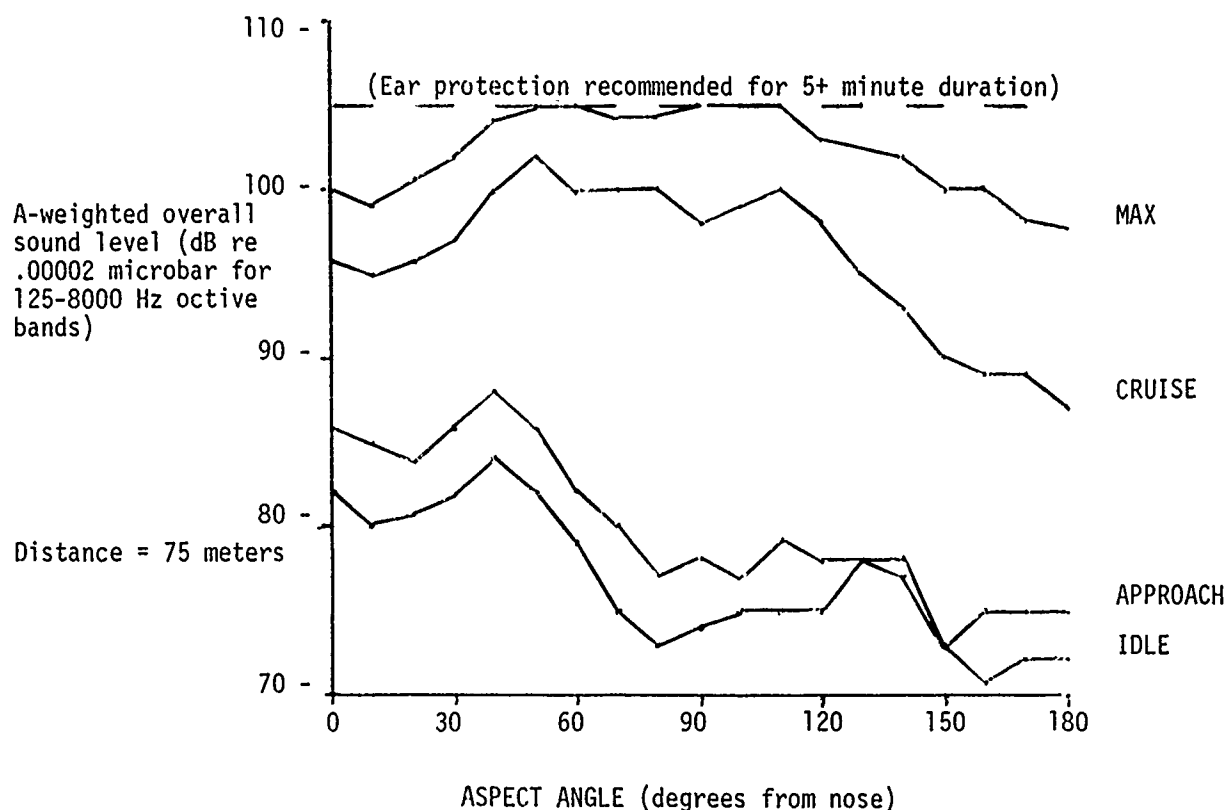
Figure 1. Graph of A-10A sound levels at various power settings by aspect angle.

<p><b>A-10A TEST RESULTS:</b></p> <p>As shown by the graph in Figure 1, relative sound levels around the A-10A at high power settings follow a different pattern than at lower power settings. Although no levels were found to present an accoustical noise hazard to airfield operations, at higher power settings (CRUISE, MAX) noise was most intense in the beam quadrant; at lower settings the front quadrant was most affected. At 75 meters, ear protection was advisable for beam exposure to MAX power noise for durations exceeding five minutes. (The specified time limit for sustained MAX power is five minutes.) Maximum exposure times are summarized in Table I.</p> <p>Near-field maintenance positions at which sound levels were sampled are shown in Figure 2. Sound levels at all of these locations with engines at IDLE were well within acceptable limits as shown in Table II. Maintenance personnel with ear protection could spend an entire eight-hour day in these positions without incurring ear damage. APU operation did not contribute significantly to the overall sound level.</p> <p>Internal cockpit accoustical noise is graphically depicted in Figure 3. Levels were</p>

well within tolerable limites as attenuated by helmet/communications unit, and were considered not to be a performance degrading factor. ECS operation contributed to the overall noise level as expected, but not to an unreasonable extent.
